MARINE INVESTIGATION REPORT

M01C0019

BOTTOM CONTACT

CANADIAN TRANSFER

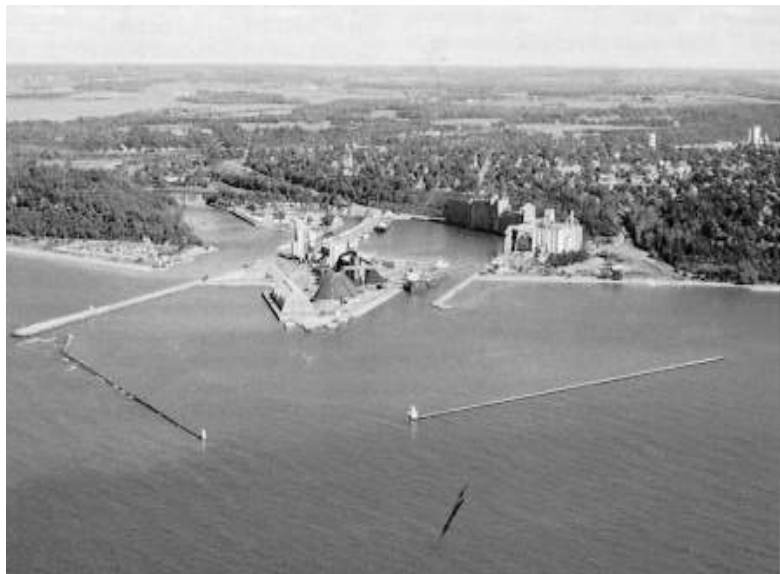
Photo 1. Goderich Harbour

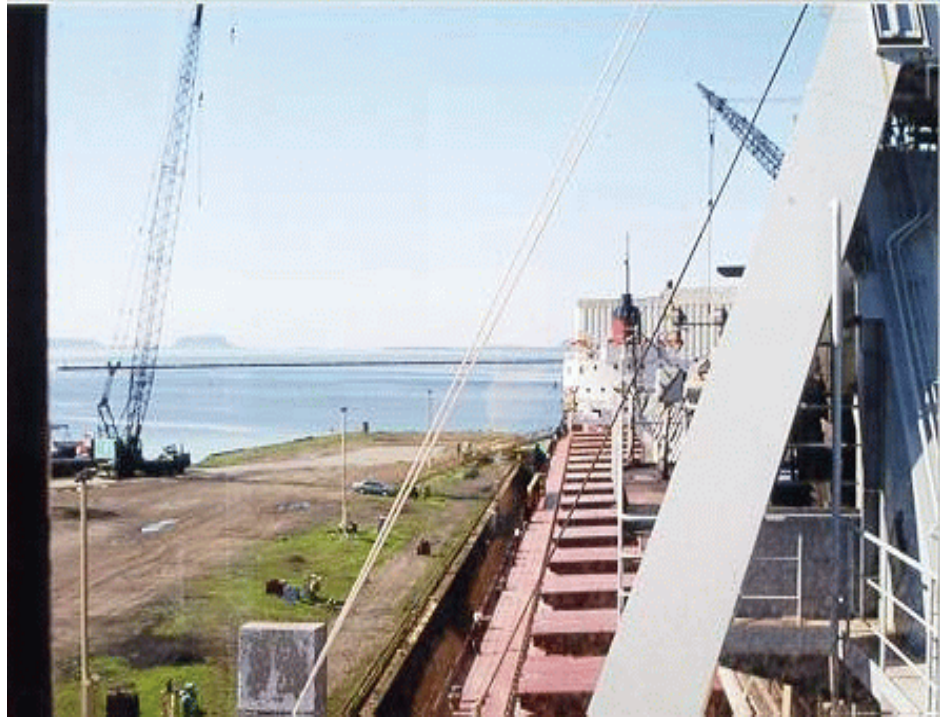
The propulsion machinery was tested prior to departure. The master reported that before departure from the dock the electronic chart precise integrated navigation system (ECPINS) had an offset placing the vessel south of its actual position. It was also found that the ECPINS unit was operating within its prescribed parameters upon inspection after the occurrence. The remaining navigation instruments were operating satisfactorily and there was no reported gyro error. A chart room is located aft of the bridge. There is a separate chart table, located at the forward starboard side of the bridge to assist the person(s) conning the vessel.

Photo 2. Starboard side of bridge looking aft

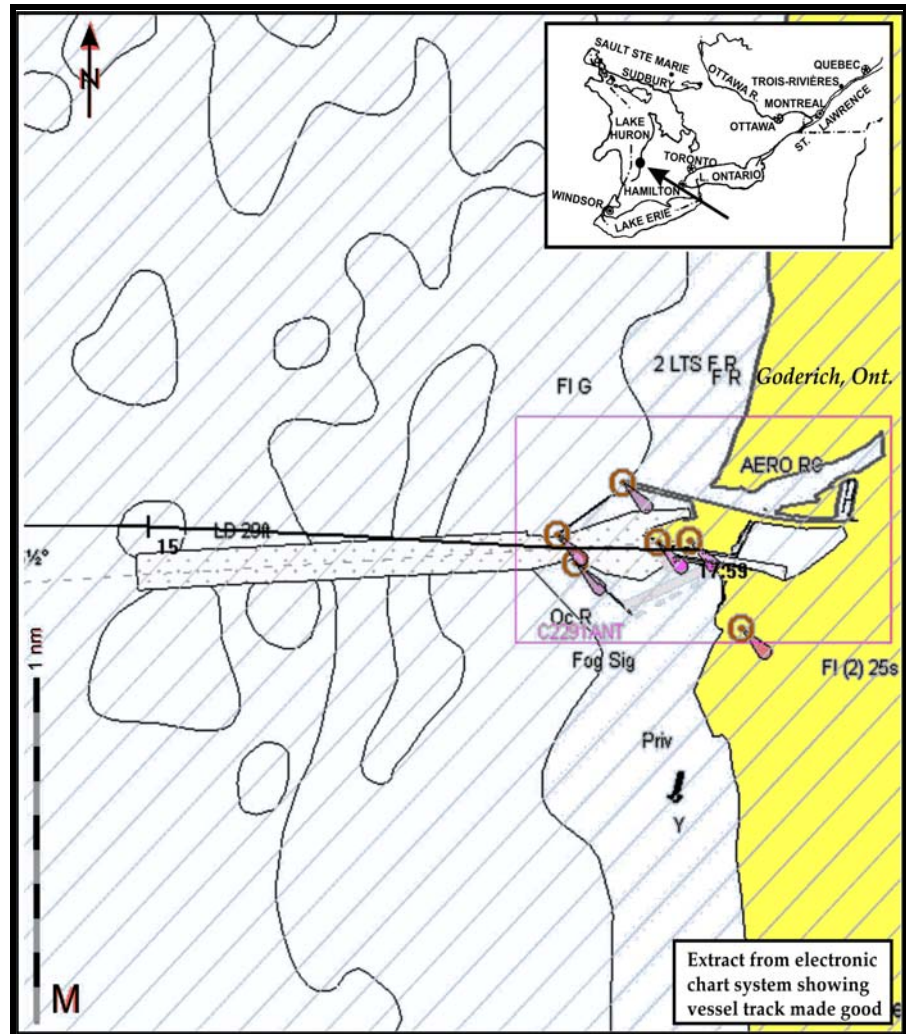
To assist inbound and outbound vessel traffic in Goderich Harbour, the navigational aid consists of a set of ranges which indicates an outbound course of 266.5° true. In the past, buoys were marking the limits of the channel but these were removed when the Government of Canada commercialized the operation of the port of Goderich and handed over its control to the municipality. The vessel was located south of the line of ranges after passing through the outer piers and was observed by the relief master to cross to the north of the range line a few minutes later.

Figure 1. Excerpt from ECPINS showing the track of the *Canadian Transfer*

The speed of the *Canadian Transfer* at the time of striking bottom was estimated by the bridge officers to be between 9.5 and 10 knots. The ECPINS unit replay showed that the vessel was proceeding at 11.4 knots. The bottom contact occurred in latitude 43°44.8' N , longitude 081°46' W, some 300 m north of the centre of the channel.

On clearing the dock, a lead-up course of 272° would bring the vessel onto the ranges and the course would be altered to between 266° and 267° to maintain the recommended track which would take the vessel clear of the harbour and approaches. This course adjustment was not made and the vessel was allowed to progress further to the north, eventually striking bottom.
